Special Report 82-33

Cold Regions Research &
Engineering Laboratory

Infrared inspection of new roofs

Charles J. Korhonen

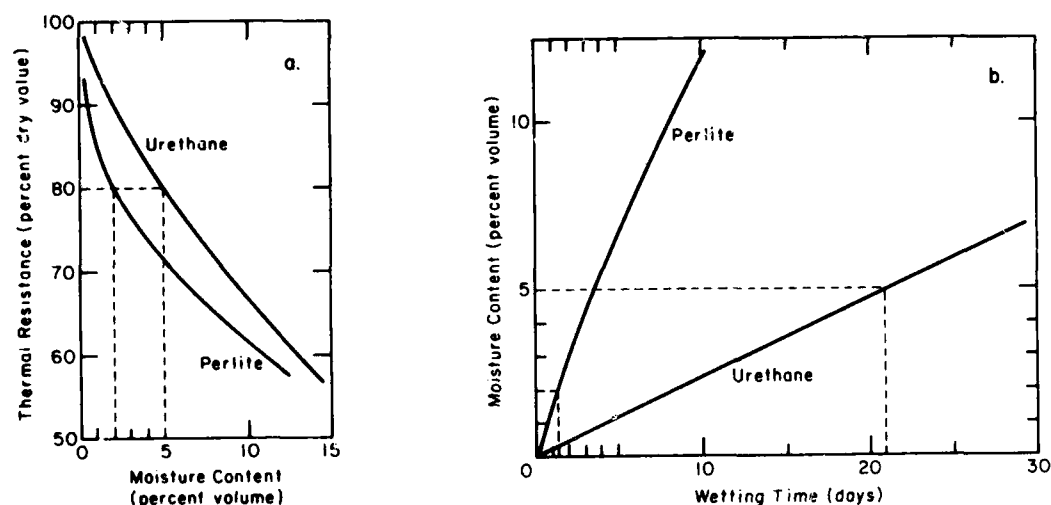
In Figure 1a we see that a moisture content of 2% by volume reduces the thermal resistance of perlite to 80% of its original dry value. In contrast, the same percent reduction in urethane's insulating ability does not occur until it has a moisture content of 5%. The relative time required to achieve these water contents under combined temperature and moisture gradients is shown in Figure 1b. It is seen that a day and a half was required to induce a moisture content of 2% into the perlite, whereas

Figure 1. Relationship between the thermal insulating value and the rate of moisture gain for perlite and urethane insulation.⁸

it took 21 days for the urethane to become 5% wet. Thus urethane not only gains moisture slower but requires more water to produce the same percent change in thermal effect on a roof.
